# LAKE CATALPA DAM

NDS ID NO. PA-560

PHASE I INSPECTION REPORT  
NATIONAL DAM INSPECTION PROGRAM

SEPTEMBER, 1980

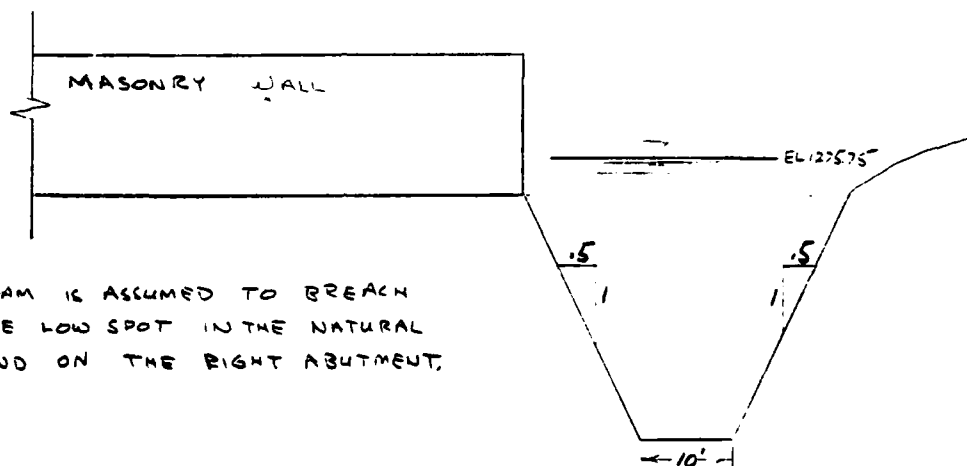
### BREACH PARAMETERS

THE DAM IS ASSUMED TO BREACH  
AT THE LOW SPOT IN THE NATURAL  
GROUND ON THE RIGHT ABUTMENT.

BREACH WIDTH (BRWD) = 10'

FAILURE TIME (TFAIL) = 4 HRS

FAILURE ELEV. (FAILEL) = 1275.75
